Problem as Experienced:

Error Code: "420106" - Shiftlock solenoid: Selector lever wrongly not locked in P.

2016 X1 F48 – sDrive 20D (B47 Engine Block)

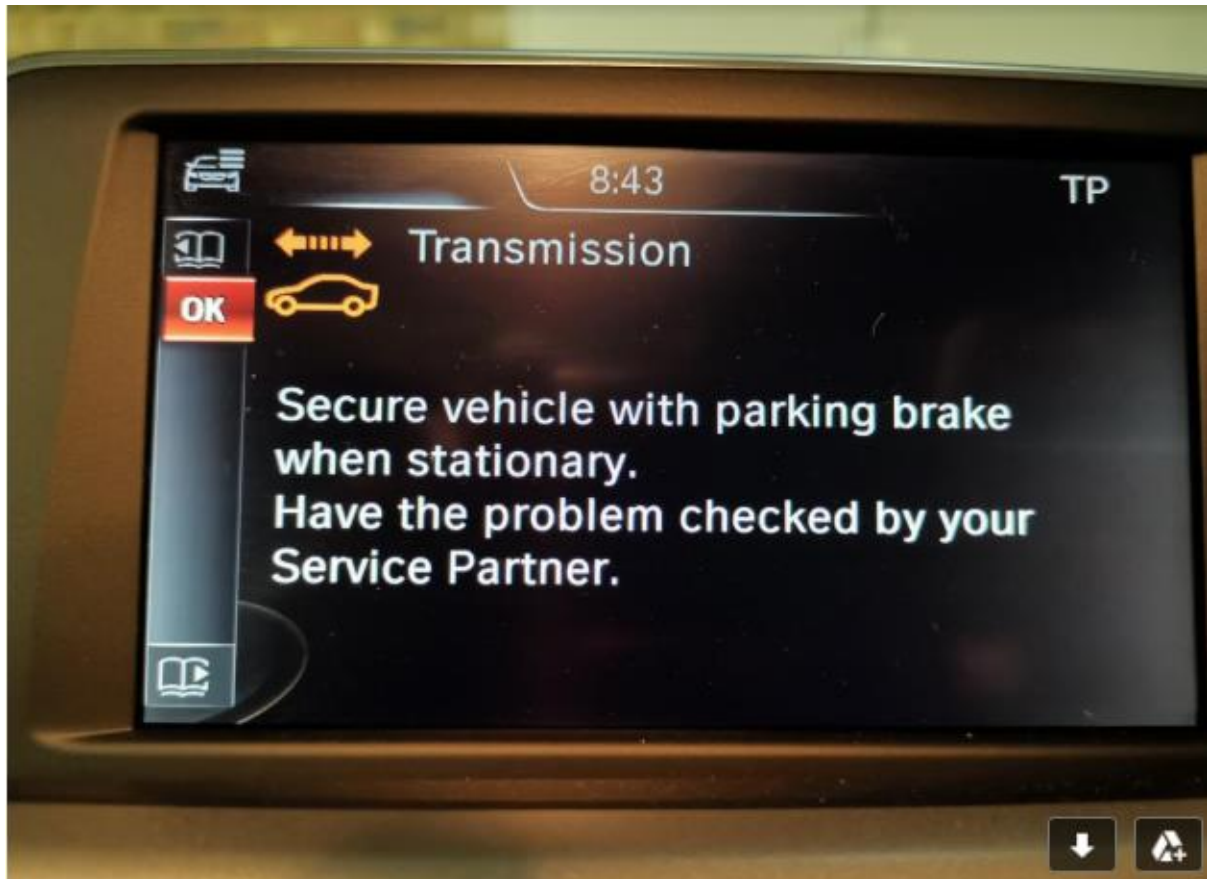
What has happened, as I have learnt, is that a small spring has broken inside the gear selector unit that holds a plastic clip in place, when the selector is in P. This WILL NOT affect the vehicle ability to drive, as the clip is only used in P. When in D or R, car will function normally. The vehicle computer throws an error as the actual transmission is in P, while the gear selector is giving info that it is in N.

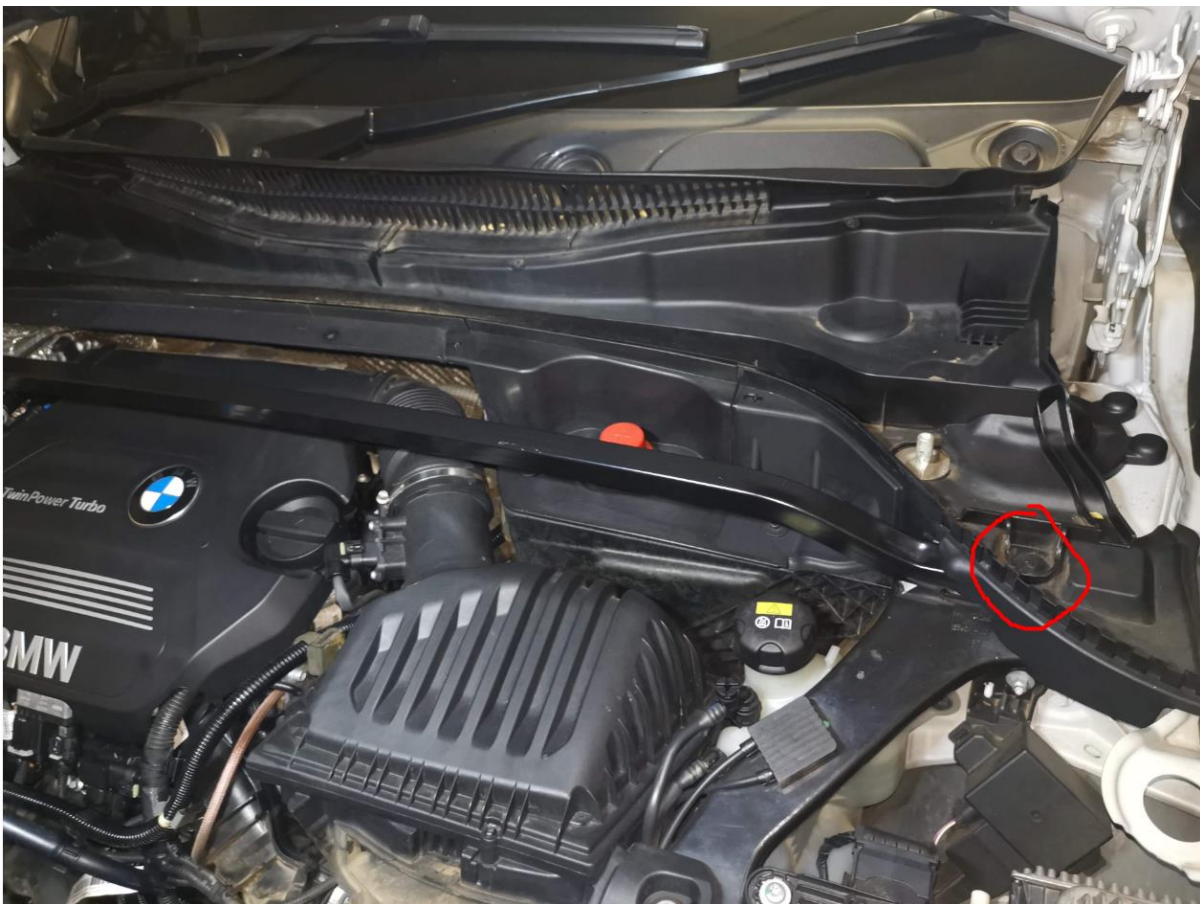
If you have had a X1 F48 for long, you know the design of the battery placement is terrible. Pop the hood / bonnet and find the 2 pin-clip studs keeping the leaf guard in place: One on the left, one on the right.

NOTE: If you have power seats – move passage seat all the way backwards before removing battery.

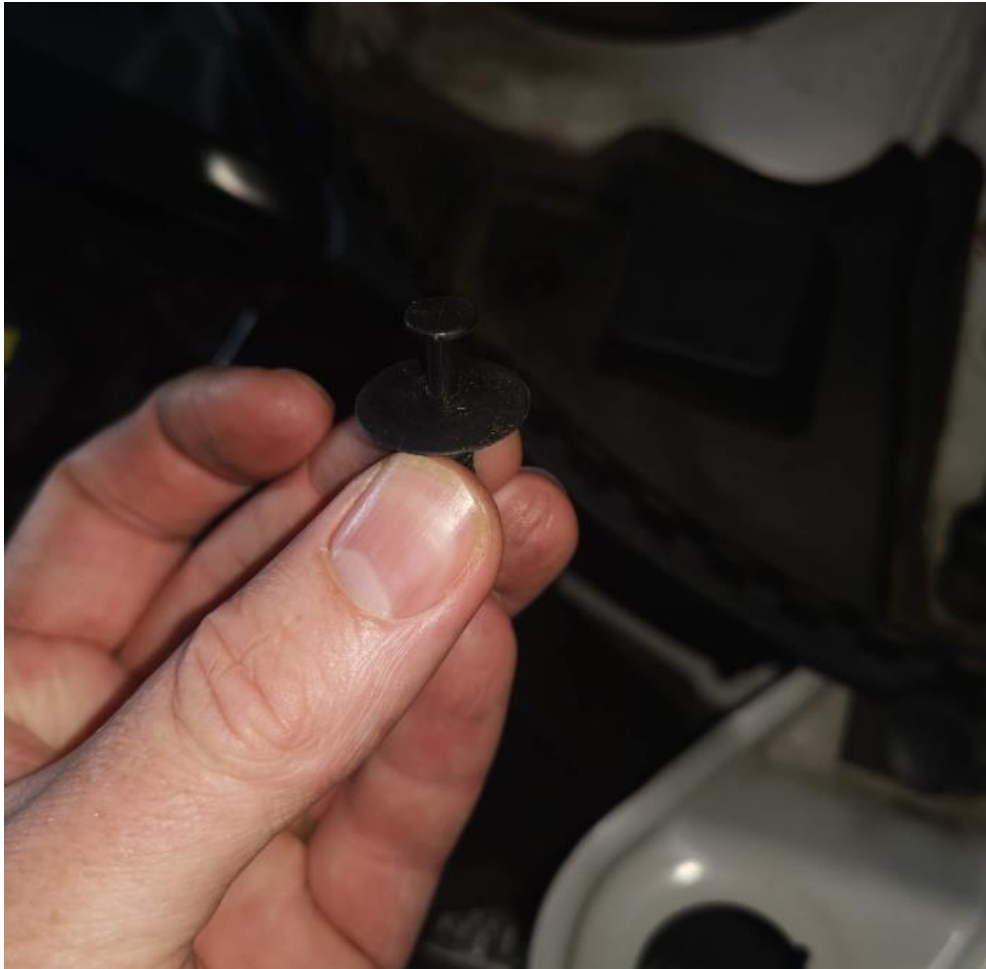
Remember to pull out the centre pin with a screwdriver or trim-tool BEFORE trying to pull the whole clip out:

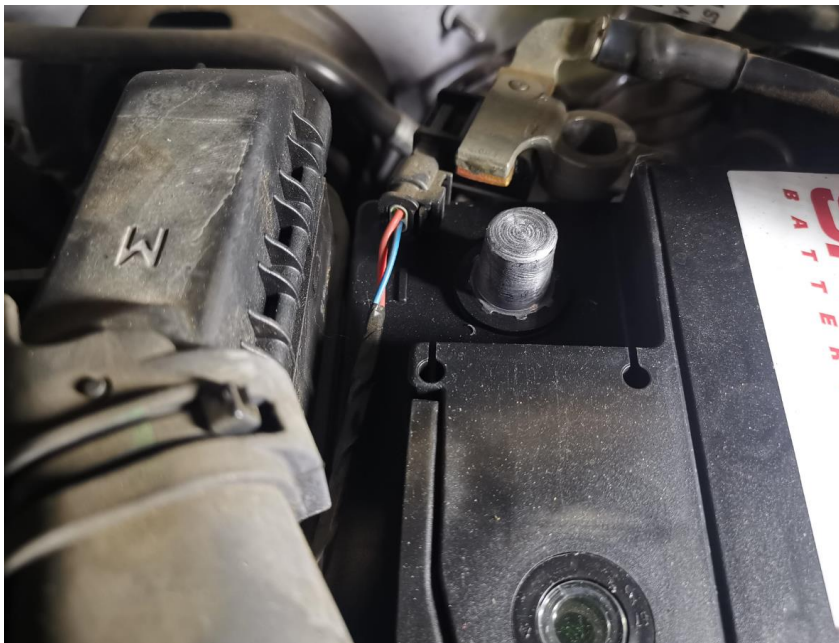
The leaf guard can pull up and out of place. This will expose the negative terminal of the battery which is all you need to disconnect. Size 10 socket.

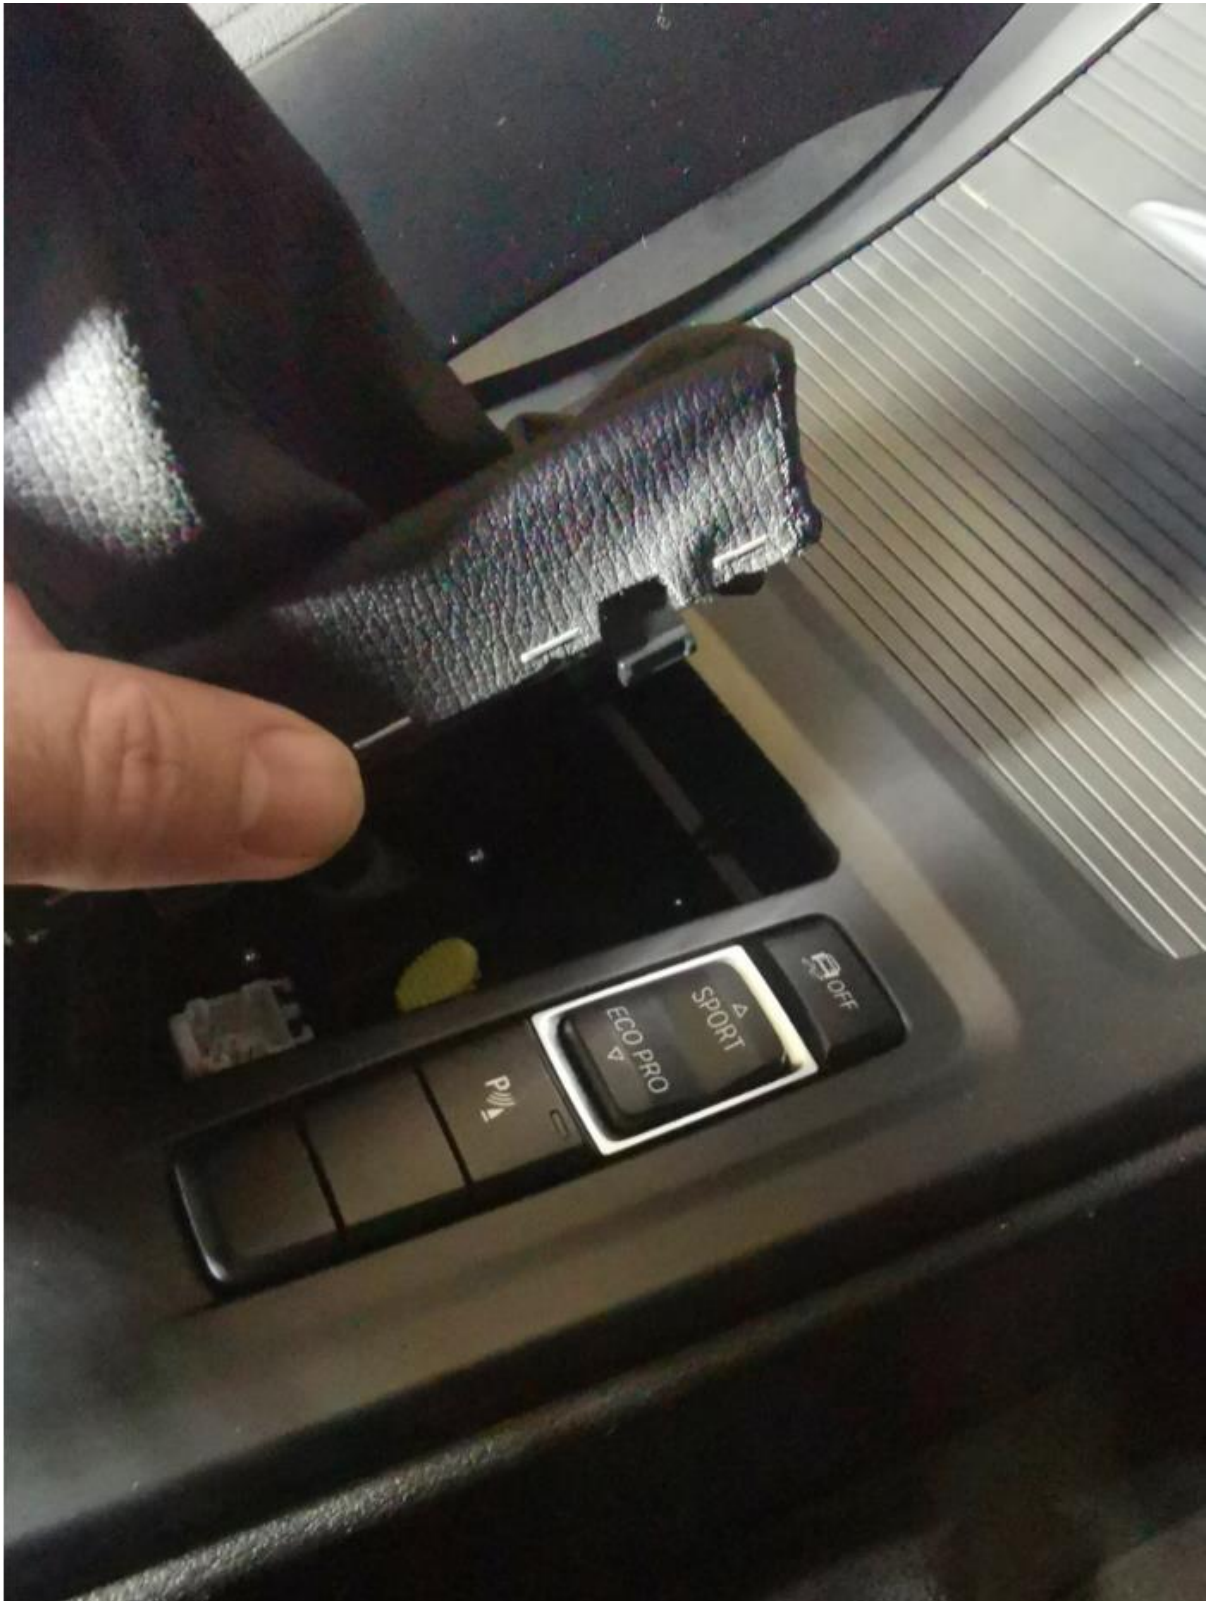
2. Remove the gear selector boot.

Simply pull the clips from the underside, and it will clip out and up.

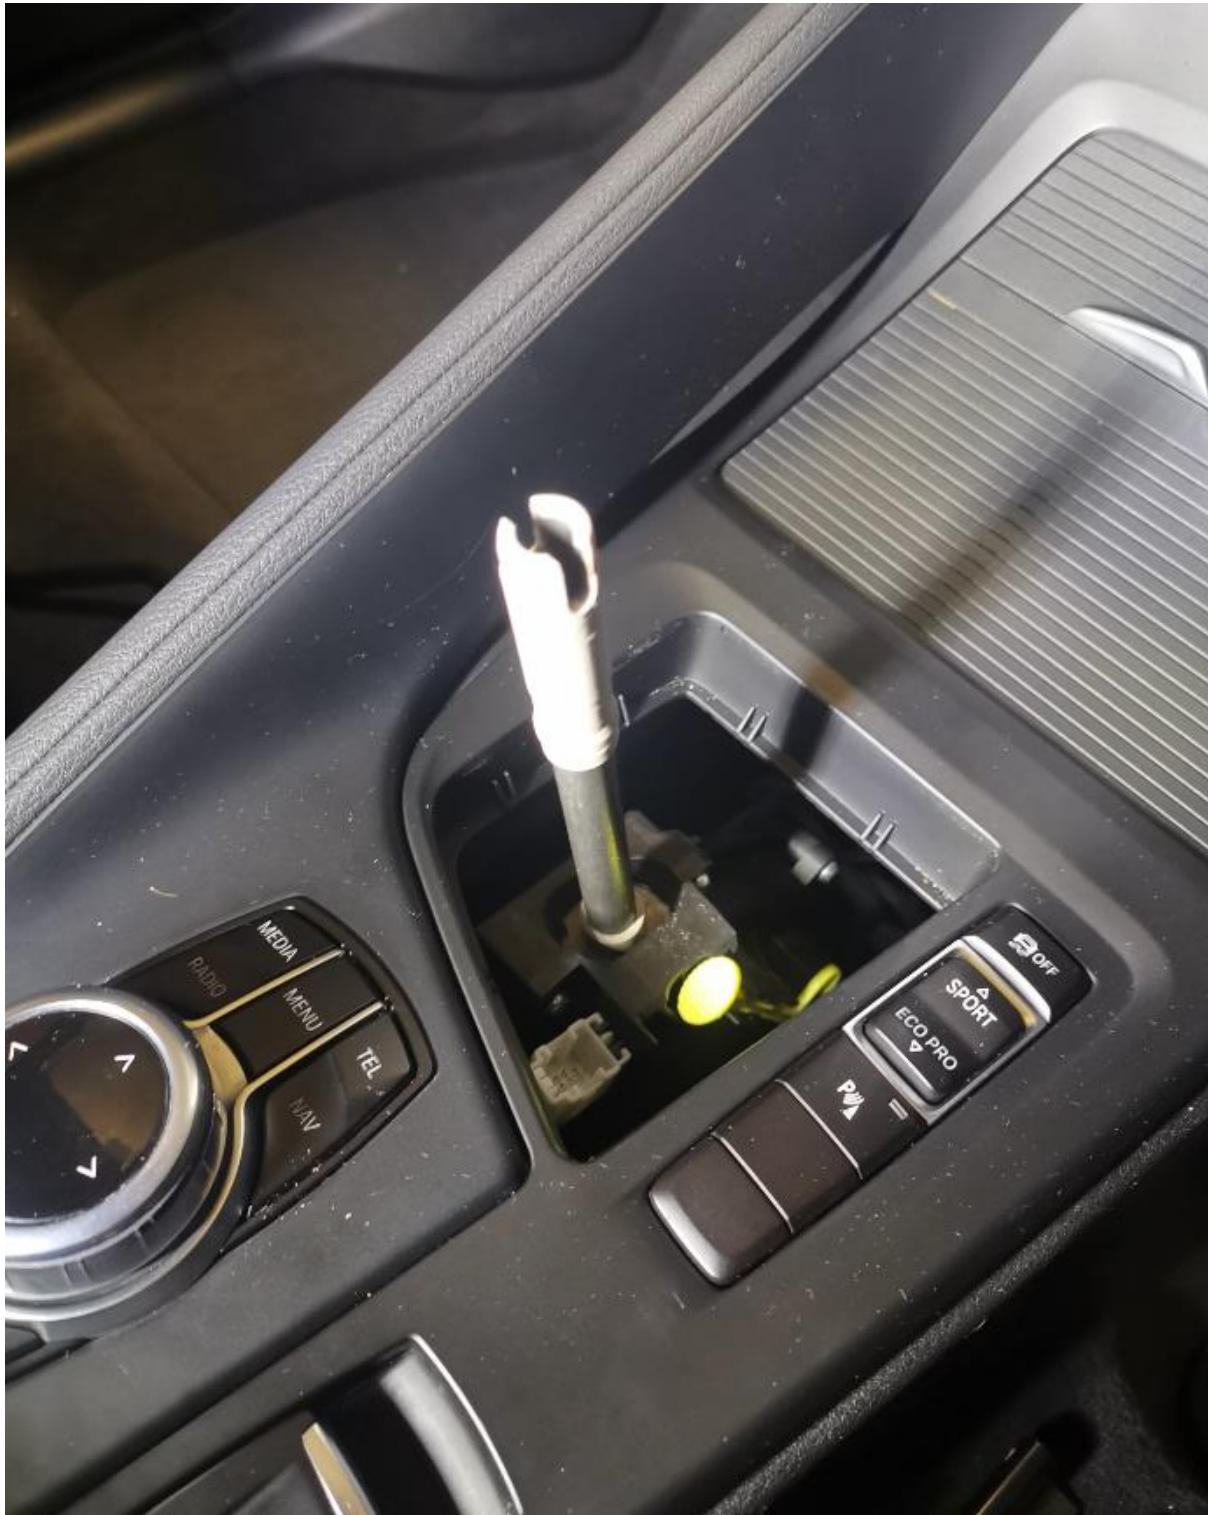
3. Disconnect the gear knob:

Reach under and disconnect the white electrical clip for the gear knob. Then, with the selector in D or N, hold the trigger used to change gears, and pull directly up. This will require some force – don't be shy but keep it strait. The whole knob will pop off and up.

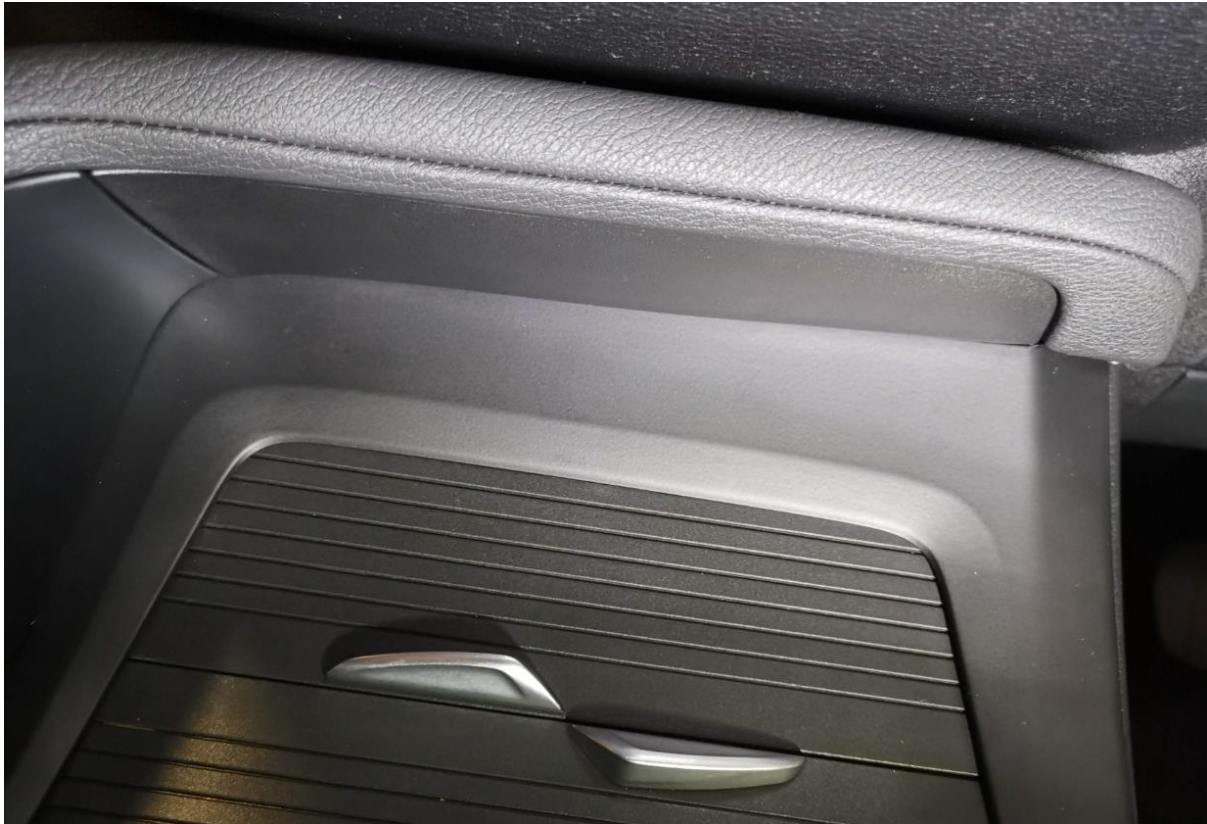
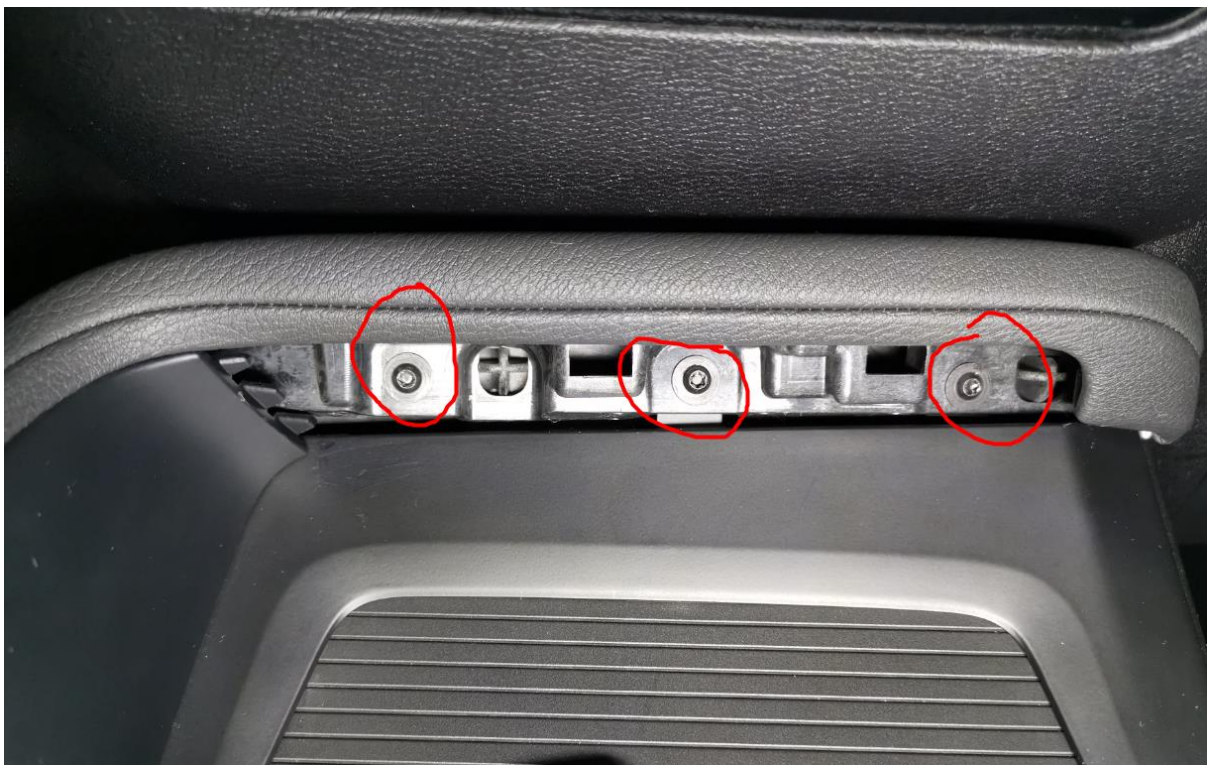
Remove trim and expose 3 hex screws in the centre above cup holders. Remove all 3 screws.
(Hex20)

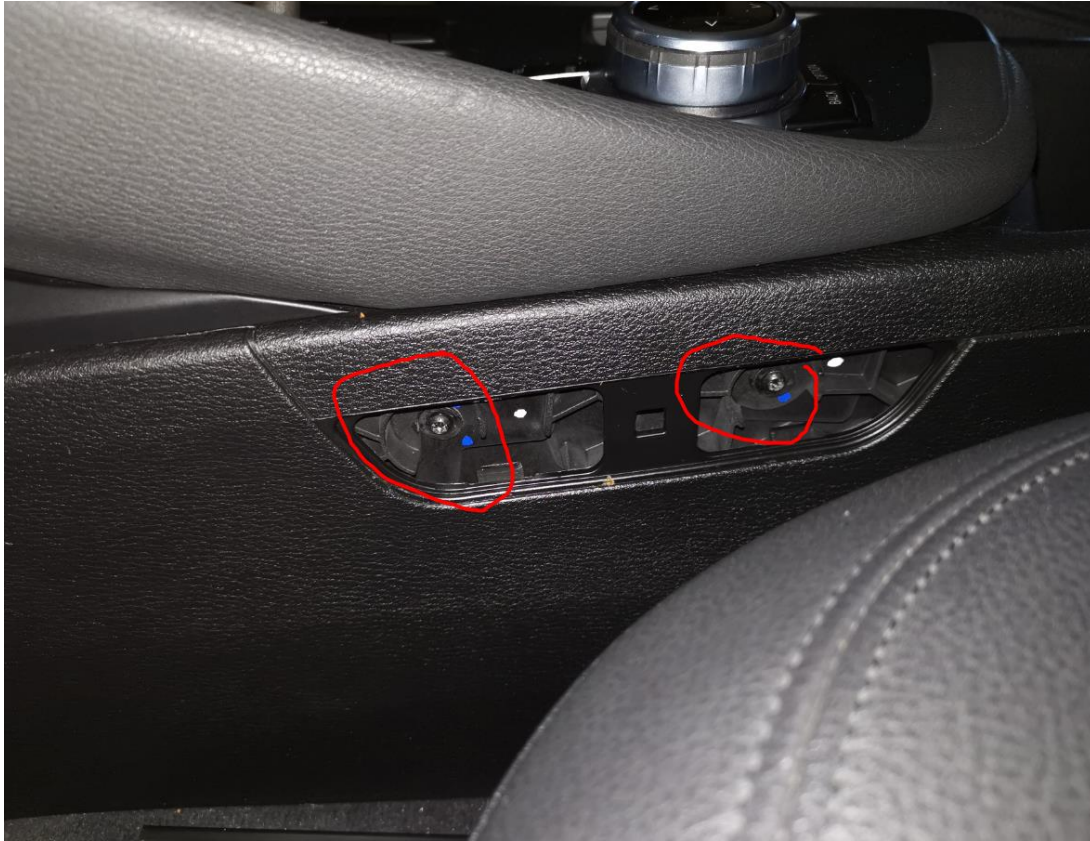
Remove trim and expose 2 hex screws on the passenger side of centre console. Remove both screws (Hex20) This can be done with the passenger seat in the car. (Put seat all the way back, and in lowest sitting position)

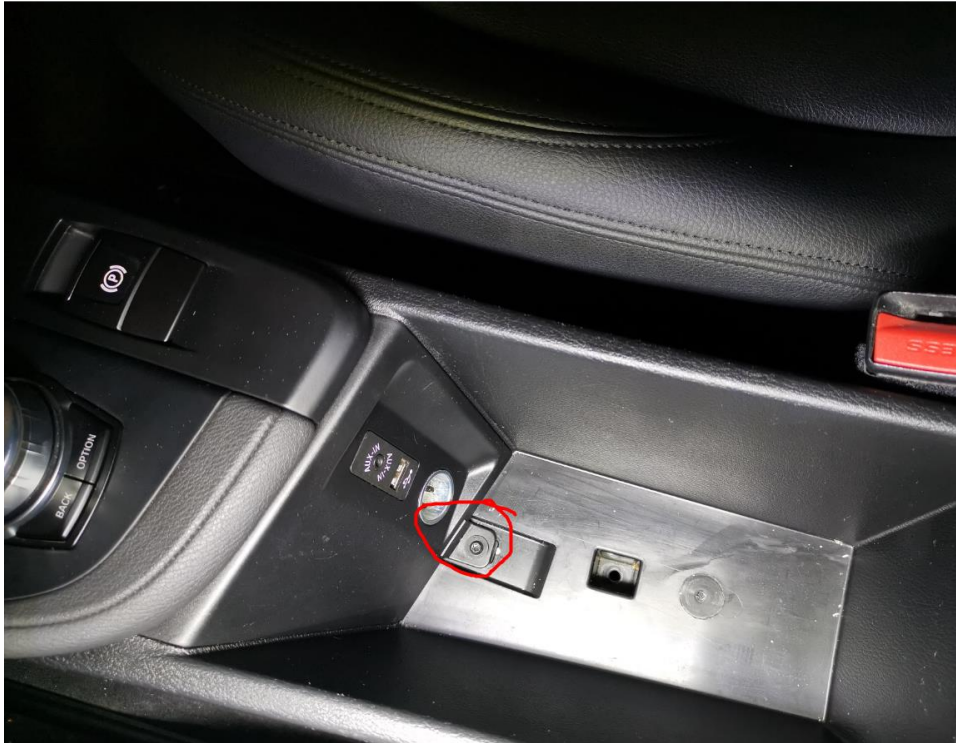
Remove plastic liner in the centre storage and expose 1 hex screw.

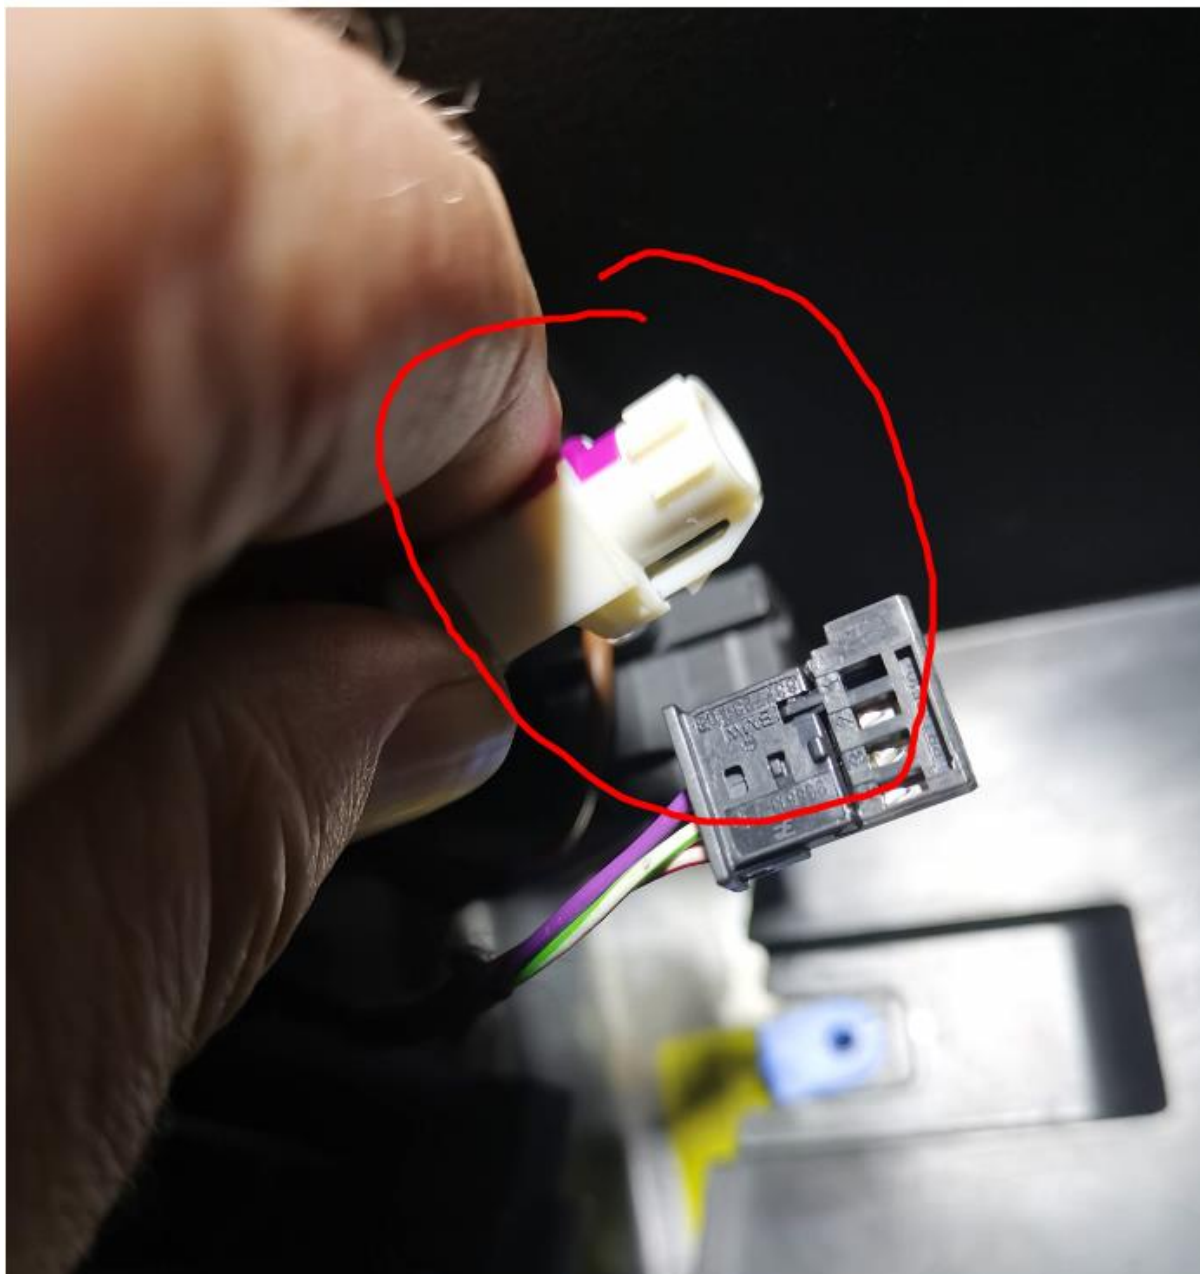
Use plastic trim tool, to pull forward the face plate with USB, Lighter socket and Audio. There are 2 clips at the top that will pop off.

Remove all 3 electrical connectors.

NOTE – White connector for the USB has a clip on the underside that will need to be squeezed to remove.

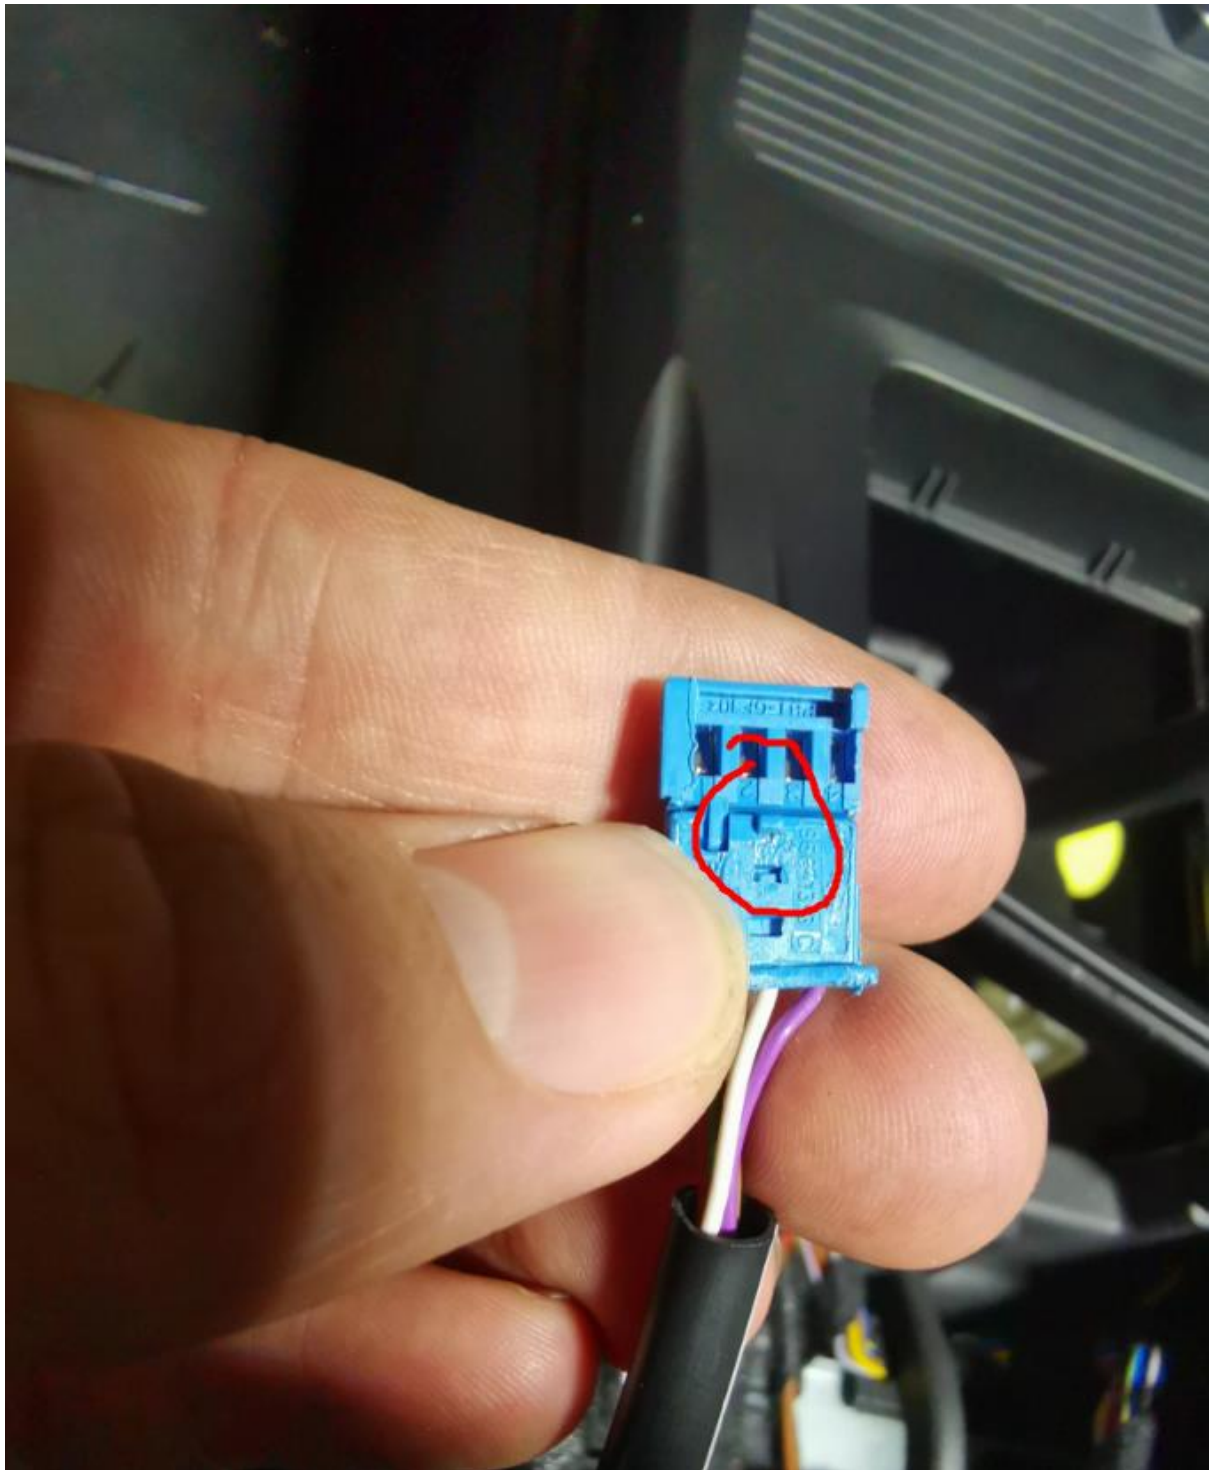
Now the full piece of dash with the iDrive controller can be removed. There are clips all round and the whole unit will come out.

As you can see, my car has the 4pin iDrive CiC connector.

The blue connector for the iDrive is VERY tight (it was in my car) and the plastic seems very soft, so be careful. I used a tiny / jewellers screwdriver to push the clip back to get it out.

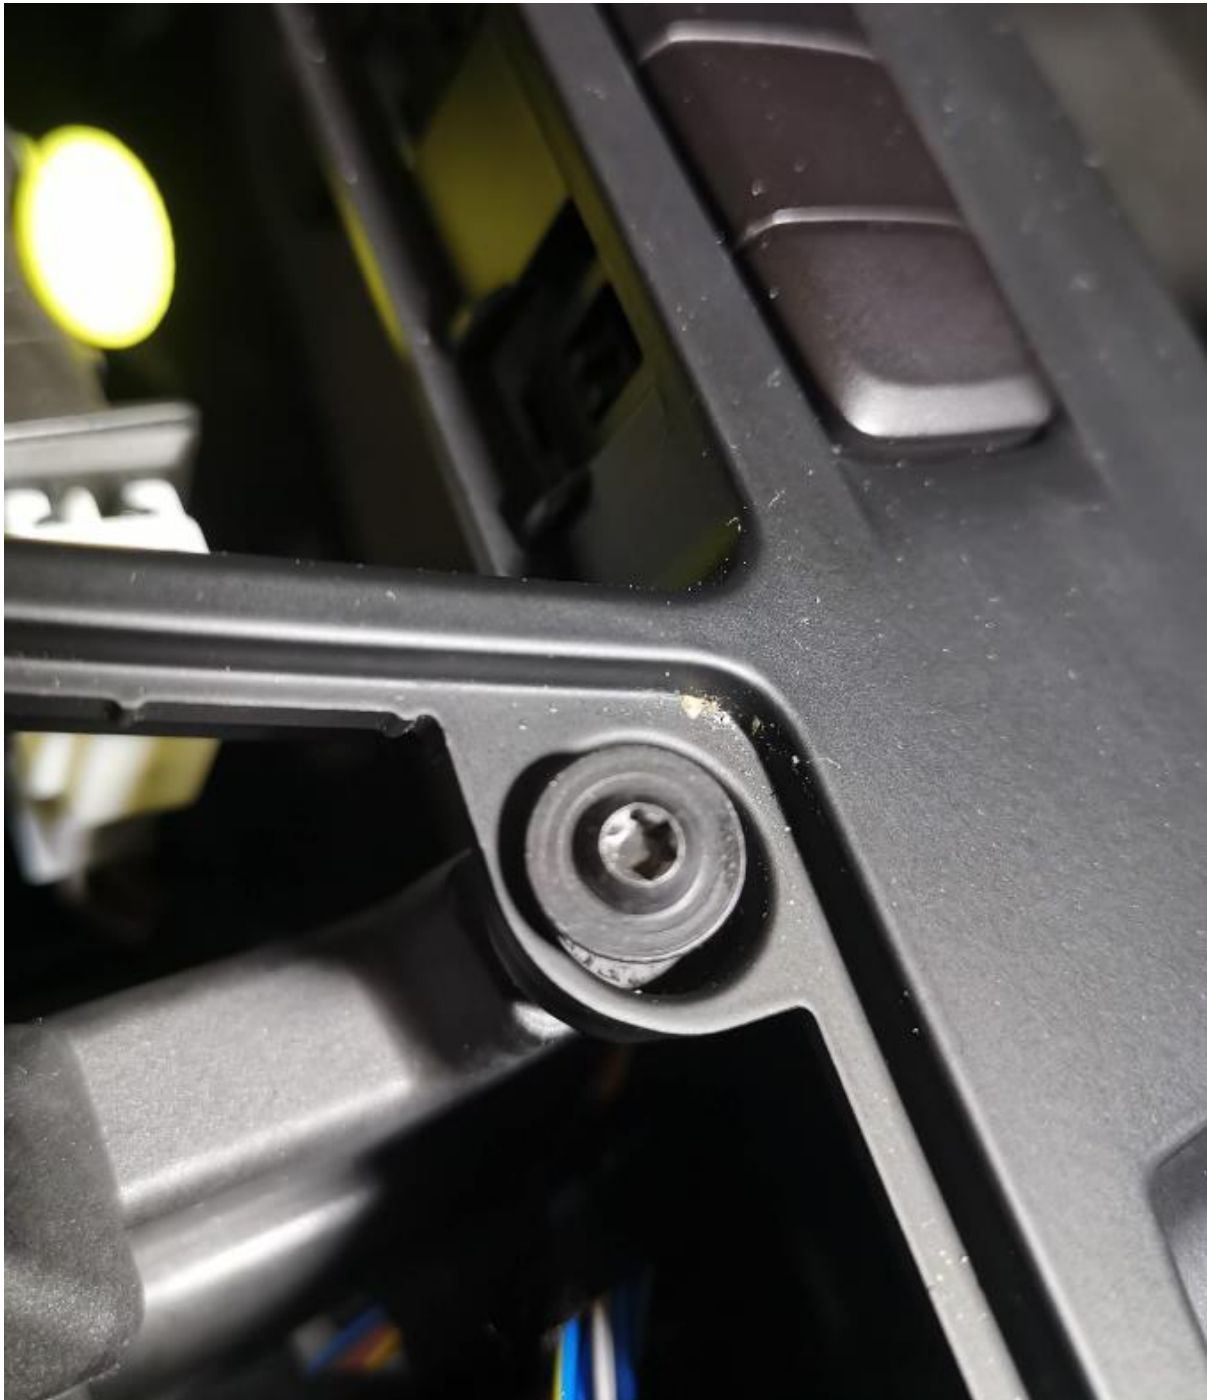
Remove the remaining centre console with drive style and park break buttons. There is 1 hex screw to be removed (Hex20)

The whole piece will unclip and lift away. Carefully lift over gear selector.

2 electrical cables will need to be removed for drive style buttons and park break / e-brake.

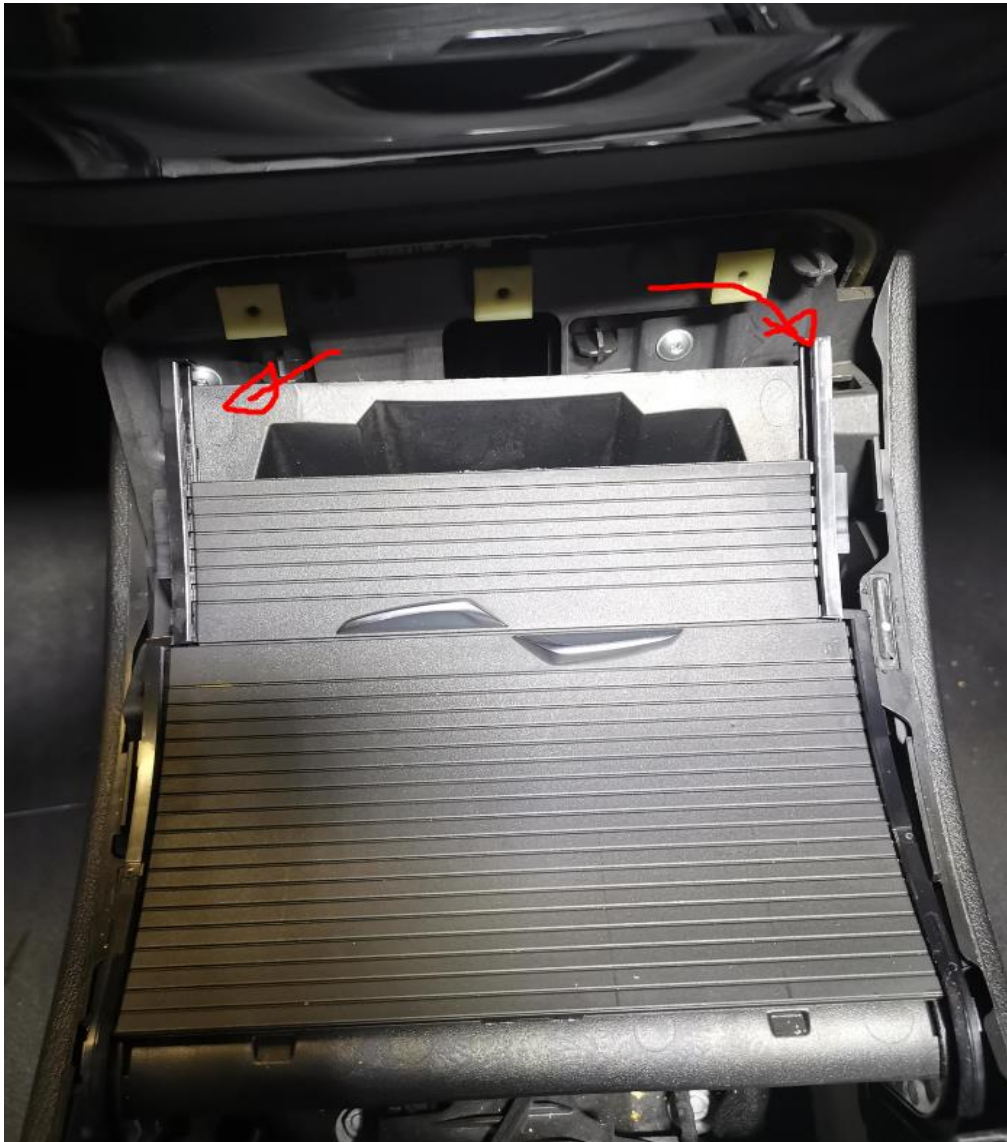
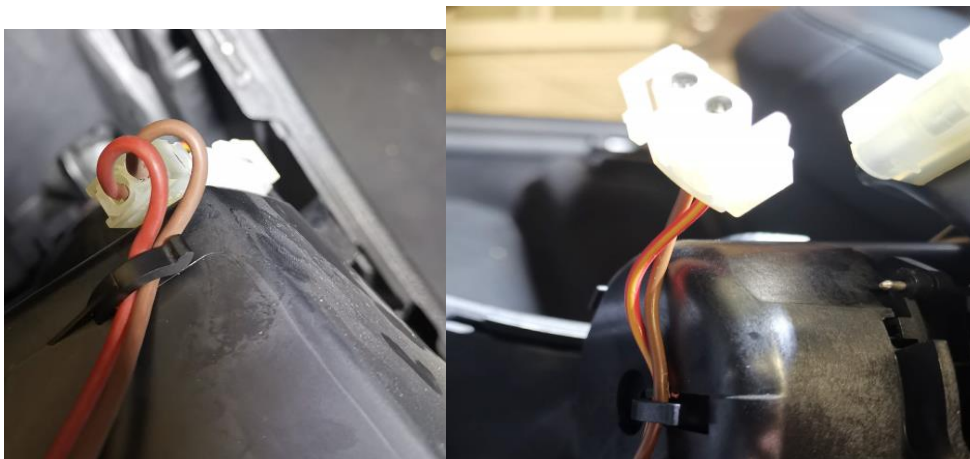
There are 2 clips as the back of the full unit. Pull from the back, and the whole assembly, will rotate forward. Once the assembly is in the vertical position, it can be lifted out of place.

There is 1 power clip for the lighter socket. This is a squeeze clip.

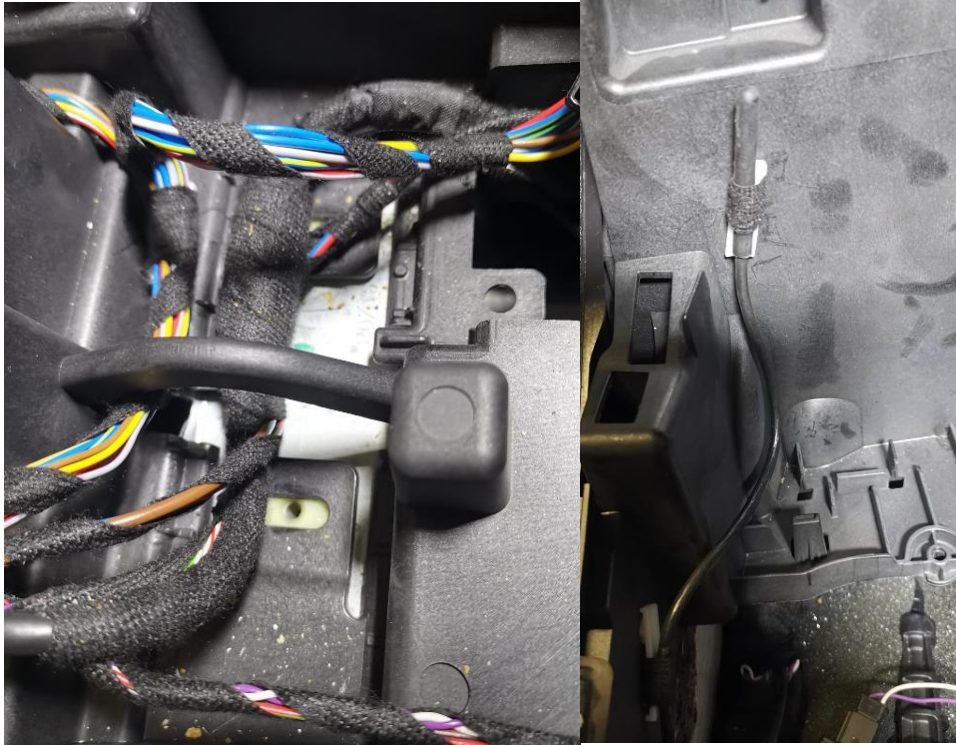
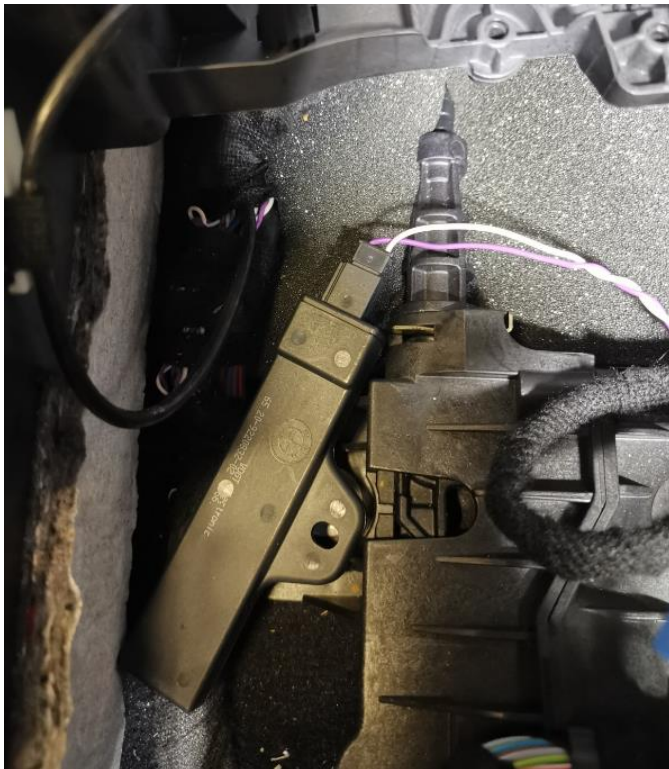
Take note of the route the cables go, and move them all out the way. There are many small plastic clips that keep the cables in place, these can pull off.

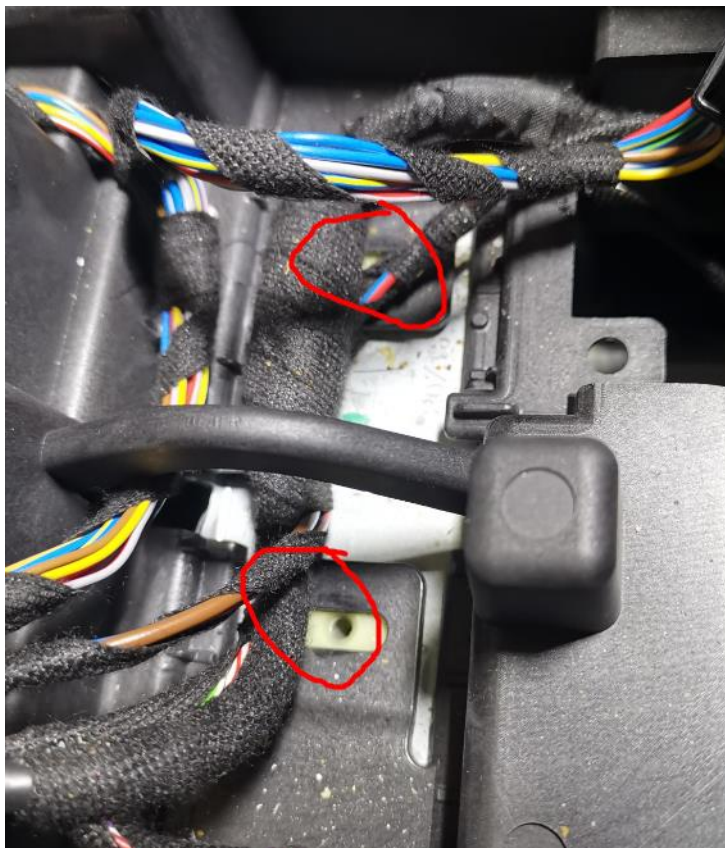
Once the 4 size 13 bolts have been removed, remove 2 more hex20 screws from the centre console.

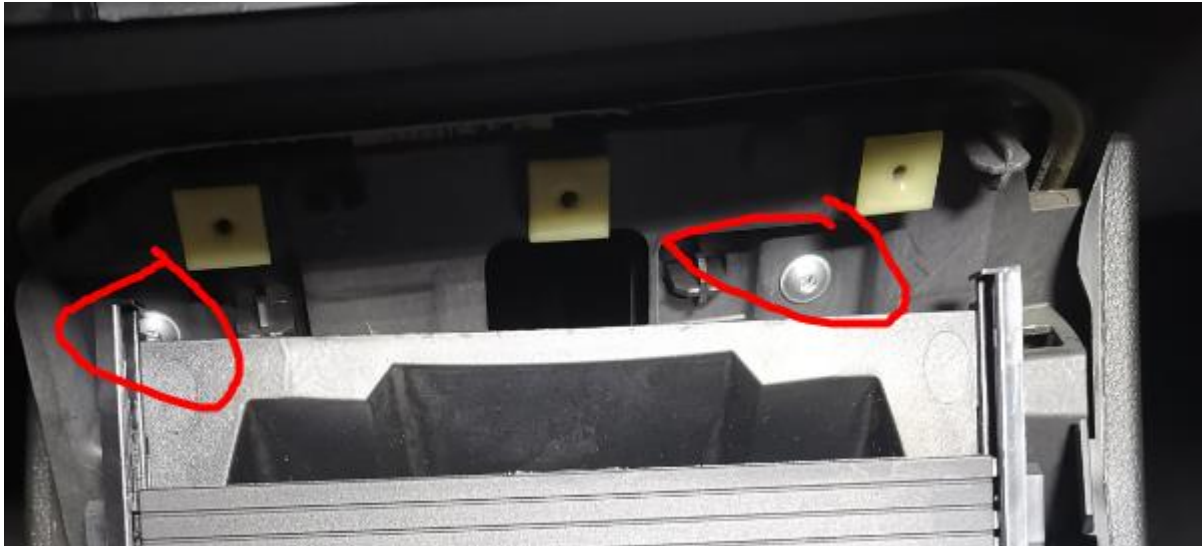
Remove the 2 silver / grey hex20 screws from the front of the console:

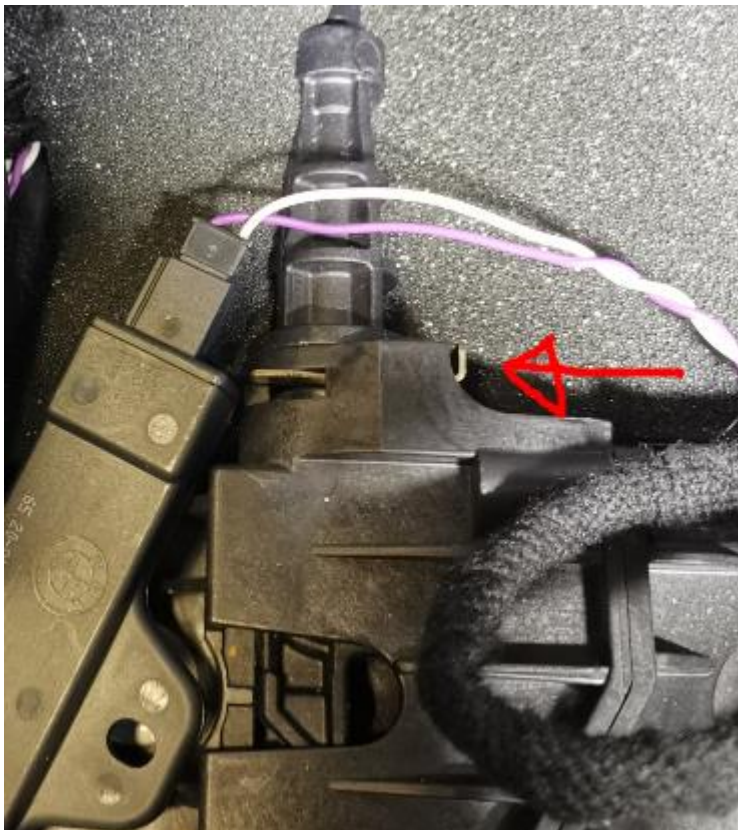
First, remove the lock clip holding in the actual gear selector cable. It can be pried back with a flat screwdriver. Don't worry, this **will** make the cable lose.

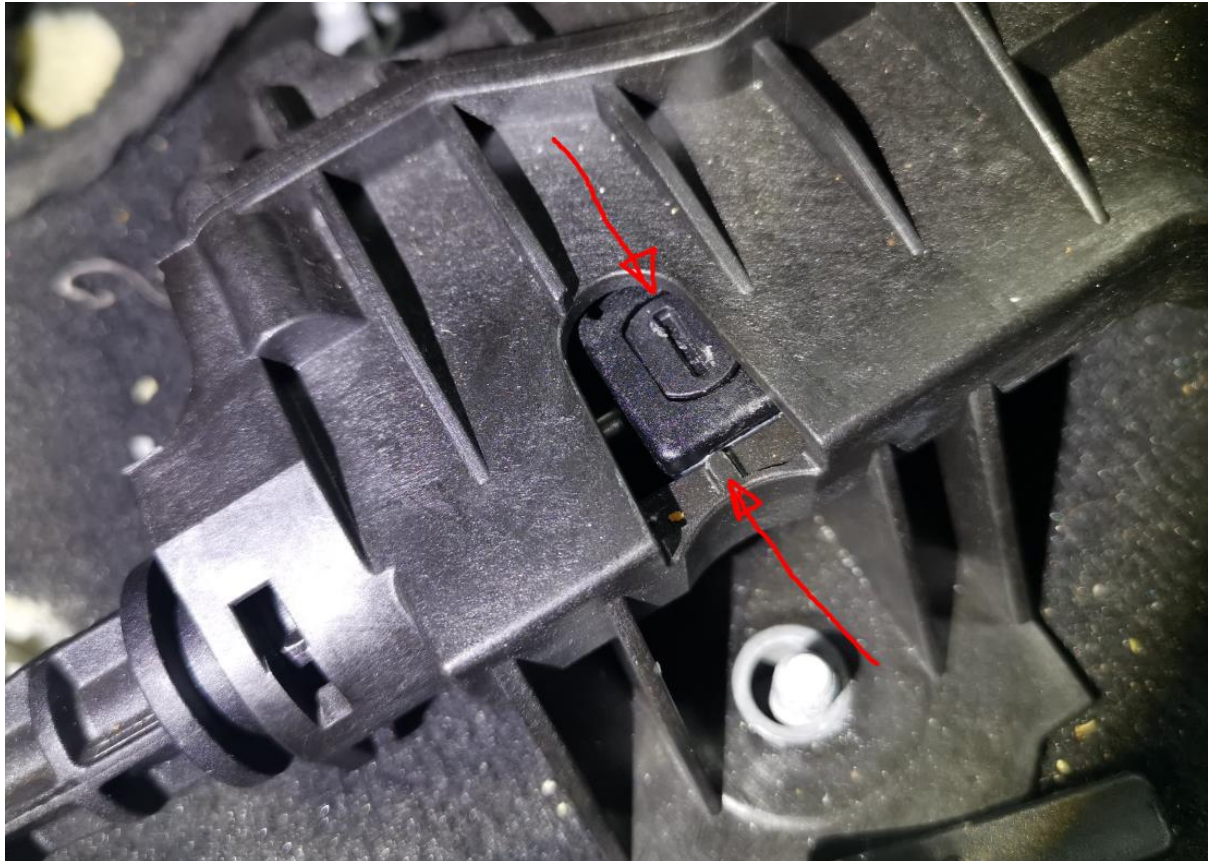
You need to find a happy place between gears and pulling the cable to FULLY expose this semi-round clip. DO NOT TRY SCREW IT.

The plastic tab on the housing, must line up with the slot on the tab. (I couldn't get a picture and get it lined up at the same time – but it must line up.
