Problem as Experienced:

Error Code: "420106" - Shiftlock solenoid: Selector lever wrongly not locked in P.

2016 X1 F48 – sDrive 20D (B47 Engine Block)

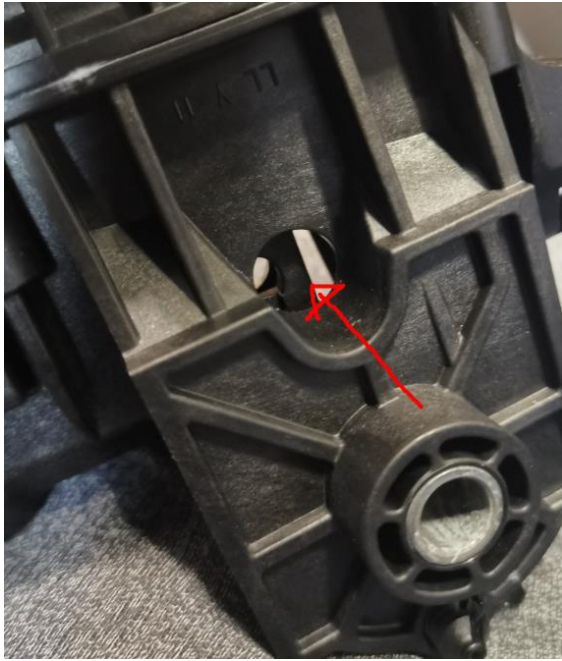
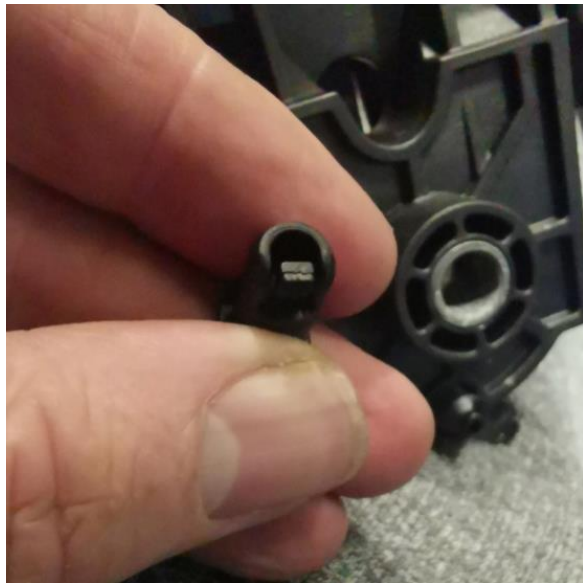
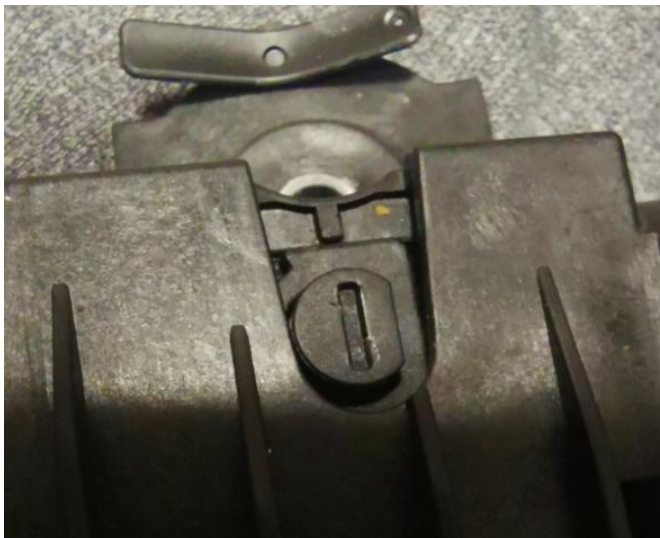
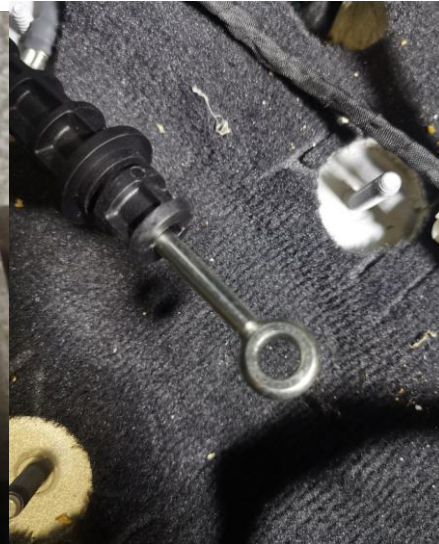
Once lined up, you need to lift the whole assembly, and rotate anti-clockwise so you can see the underside.

Where you have lined up this clip, you will see a small tab to be clipped off. This will pop out the whole clip, and the gear selector cable will come free. (Use small flat screwdriver)

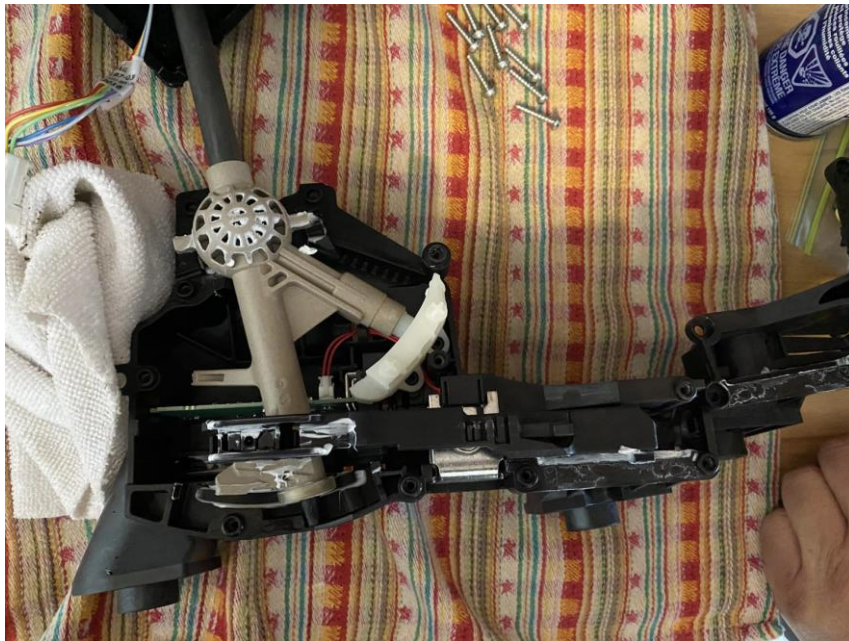
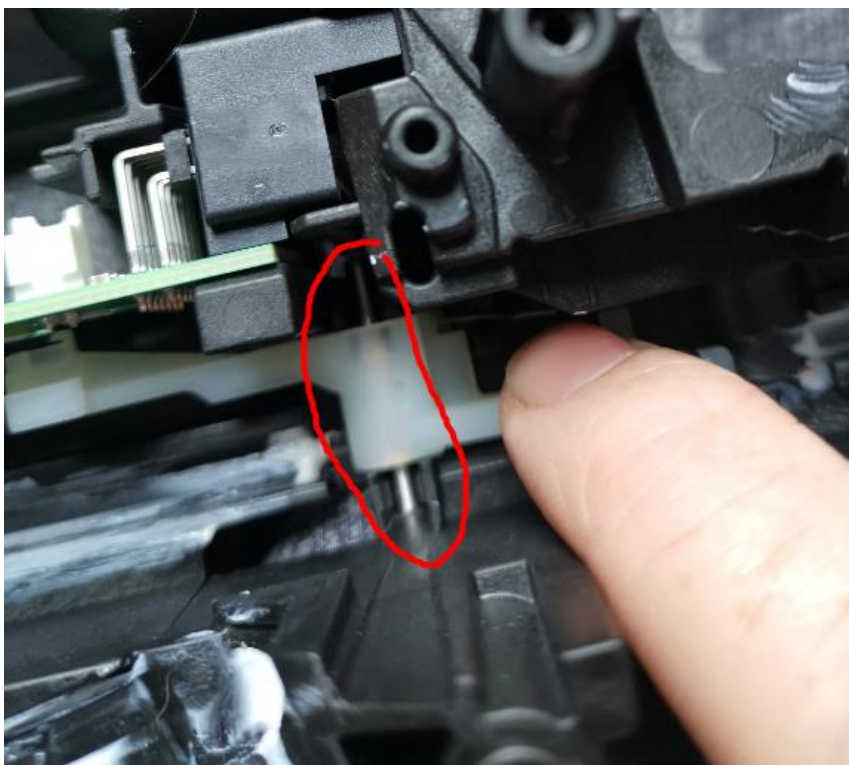
There are 11 or 12 silver screws, Hex20, remove all those screws and separate the unit into 2 halves. Be careful of the solenoid that makes the base of the unit tight together.

Remove all the moving parts – there is some grease on these parts.

Disconnect the wire for the solenoid and remove the solenoid.

Remove the entire white lever – You can press the small axle from the outside of the housing, and it will pop out. The axle, plastic lever and spring will be attached.

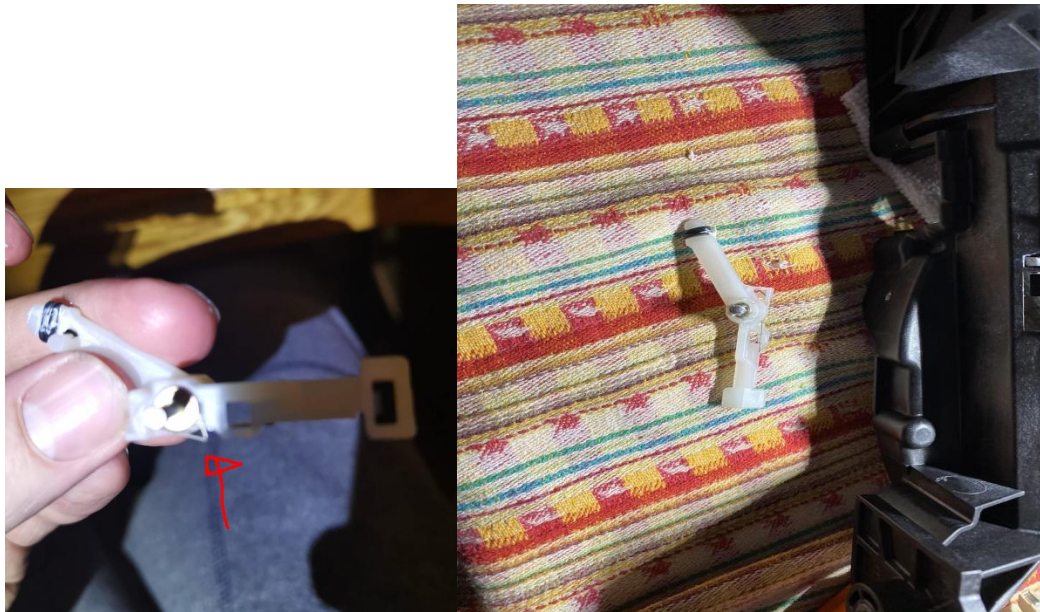
With this out, you will be able to see if the torsion spring is broken – mine clearly was. I carefully removed the spring and stretched it out 1 full revolution. It will need to be **past** 180degrees to push the white lever up.

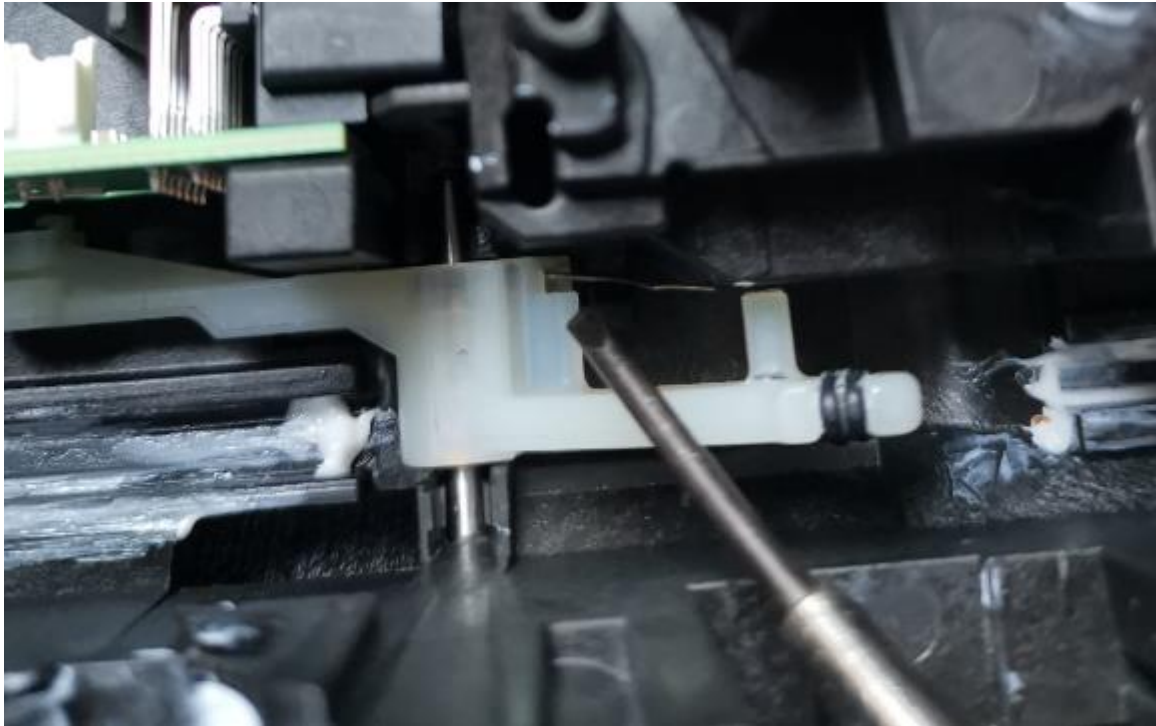
Here is the unit with the spring back in and resting:

The left side (under the circuit board) must always be pushed DOWN by the spring, and is only pushed up when the selector is slid into P. In that position, that white lever is pushed up, and the magnet is OVER the sensor on the circuit board.
