<u>BMW F48 X1 xDrive18d SAV / Repair Manuals and Technical Data</u> / <u>51 Body equipment</u> / <u>51 43</u> <u>Side Trim Panel with Armrests</u> /

51 47 000 Removing and installing/replacing front (inside) left or right door sill cover strip

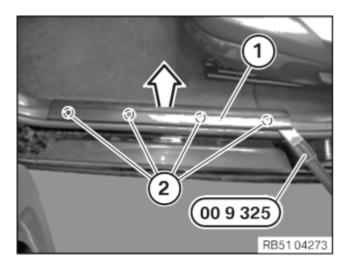
Do not raise door sill cover strip (1) over entire length simultaneously.

Unclip rear door sill cover strip (1) from clips (2) starting from the rear with special tool 009325.

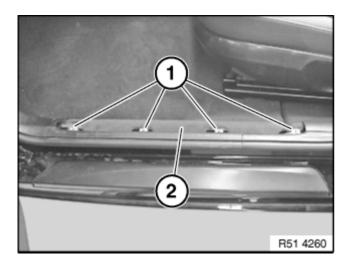
If necessary lift clip (1) from floor panel (2) and clip on door sill cover strip.

Installation note: Replace defective clips (1) on door sill cover strip (2).
