[BMW F48 X1 xDrive18d SAV / Repair Manuals and Technical Data / 51 Body equipment / 51 12 Rear bumper /](#)

51 71 478 Removing and installing/replacing the rear left or right wheel arch trim

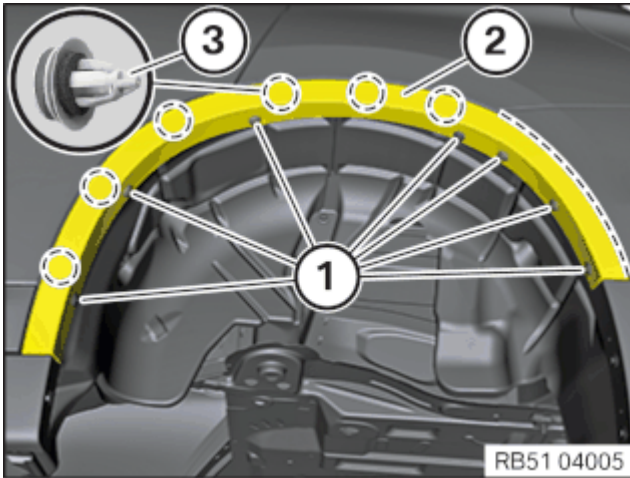
Remove the blind rivet (1).

Disengage the trim (2) from the clips (3) around the side panel.

Loosen and remove the trim (1) from the latch mechanisms on the bumper.

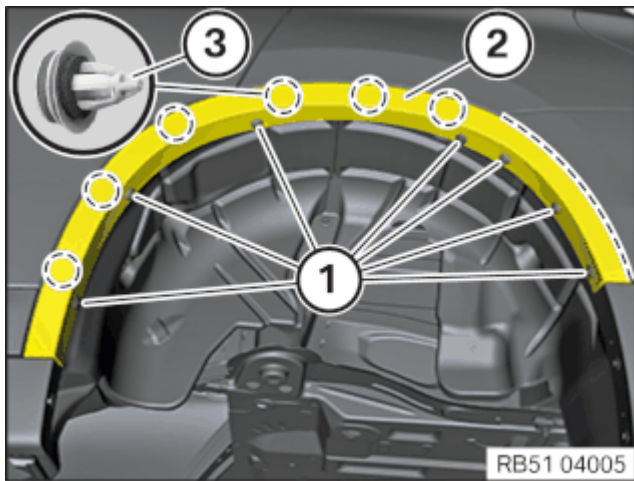
Note:
Renew faulty clips (3).

Insert the trim (2) and engage with the clips (3).

Engage the trim (2) with the latch mechanisms on the bumper.

Install the blind rivet (1) using special tool [00 2 230](#) .
