[BMW F48 X1 xDrive18d SAV / Repair Manuals and Technical Data / 51 Body equipment / 51 47 Floor/luggage compartment/engine compartment, trim panel /](#)

51 46 050 Removing and installing/replacing top cover on tail panel

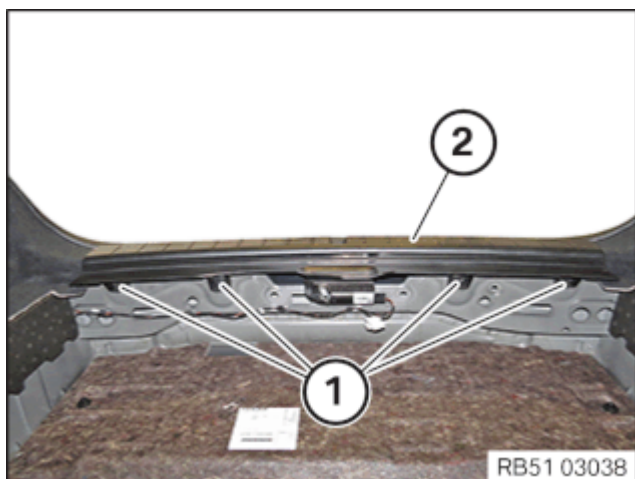
Release expanding rivets (1) from tail panel trim (2).

Lift off trim on tail panel (2).

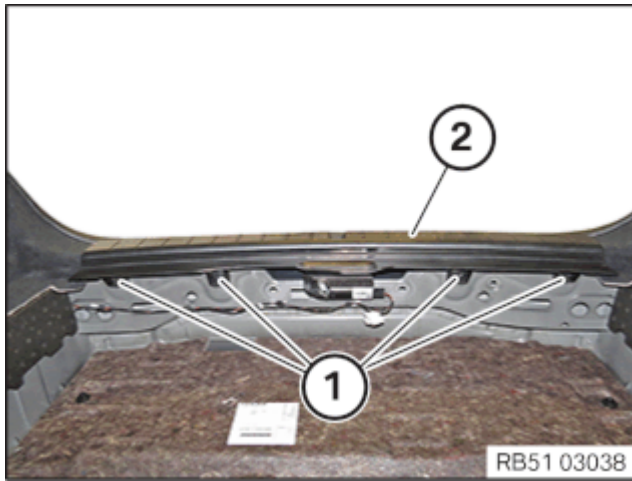
Install trim on tail panel (2).

Mount expanding rivets (1) on tail panel trim (2).
