[BMW F48 X1 xDrive18d SAV / Repair Manuals and Technical Data / 51 Body equipment / 51 47 Floor/luggage compartment/engine compartment, trim panel /](#)

51 47 161 Removing and installing/replacing right luggage compartment wheel arch panel

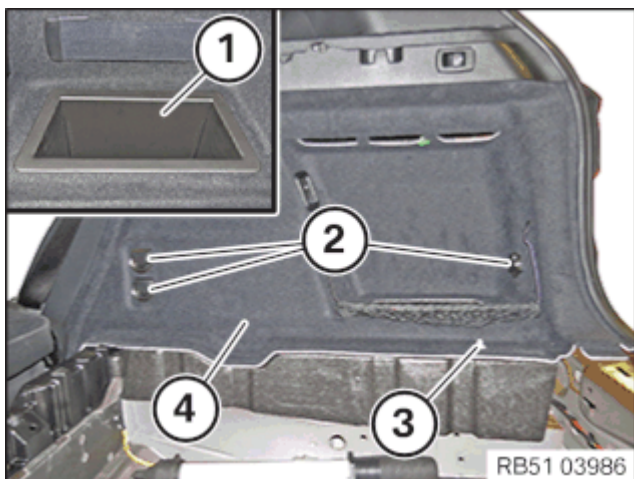
Lift out storage compartment (1) upwards.

Lever out lashing eye covers (2) and loosen screws underneath.

Remove the lashing eyes (2).

Remove the pin (3).

Remove the trim panel (4) towards the inside and in this process, disconnect the plug connections.

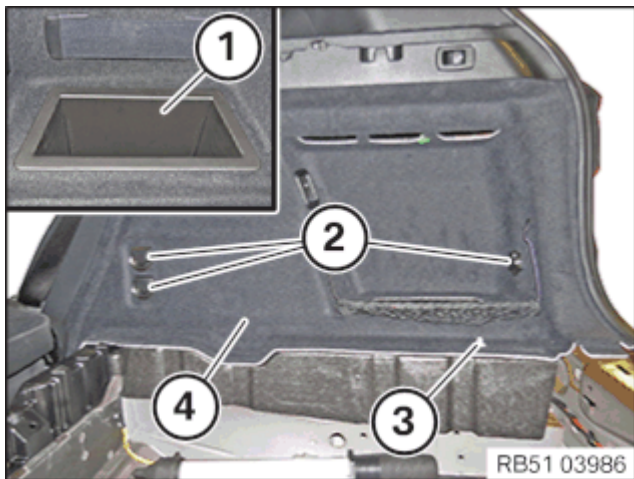
Insert the trim panel (4) and in this process, connect the plug connections.

Tighten the pin (3).

Tightening torque [51 47 6AZ](#).

Install lashing eyes (2) and tighten screws.

Tightening torque [51 47 1AZ](#).

Install lashing eye covers (2).

Install storage compartment (1).
